HURRICANE HUGO DAMAGE ASSESSMENT INVENTORY
ADDRESS: 2714 Jasper Boulevard
NAME: Carter-Nanney House

TMS 529-7-0-20
SITE • 310
Survey/• SI 47

DATE: 2/6/90

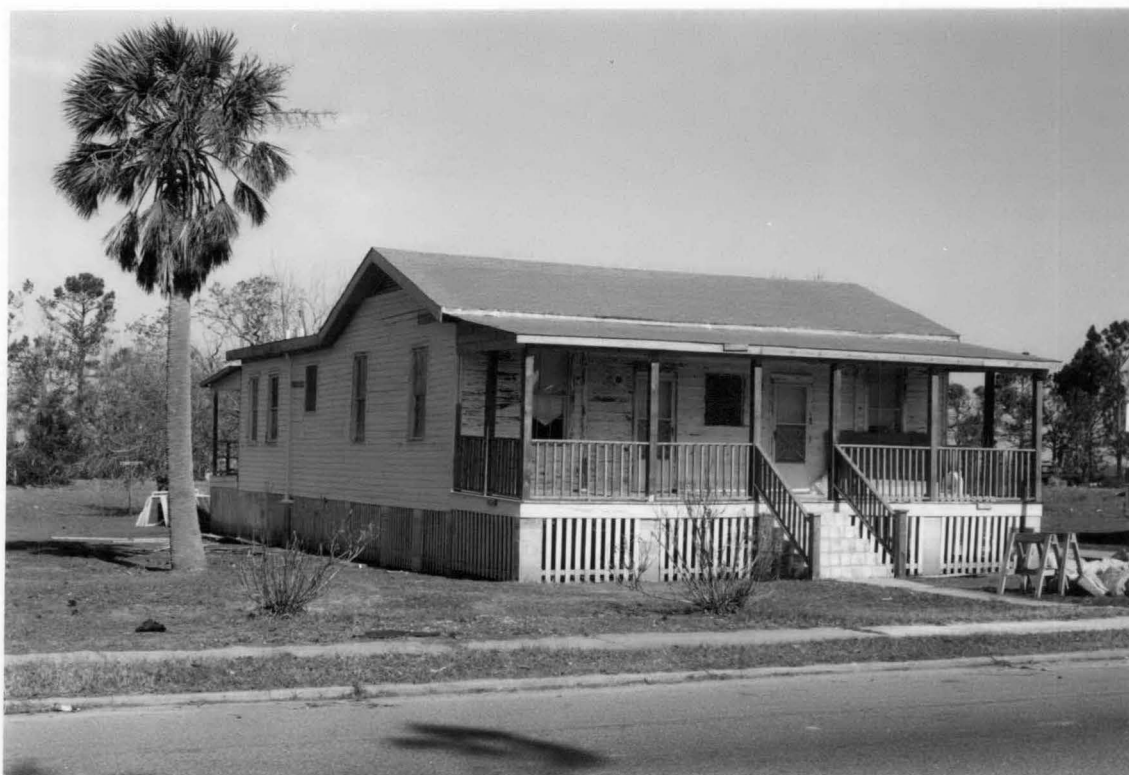
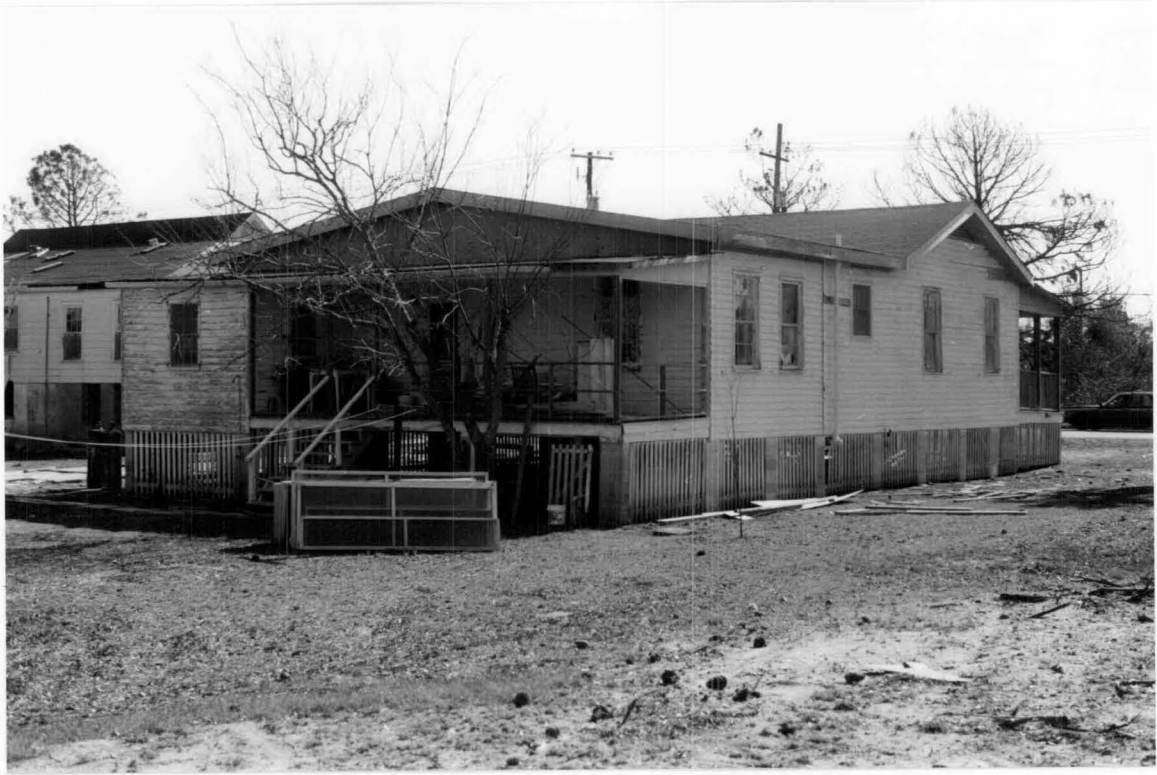
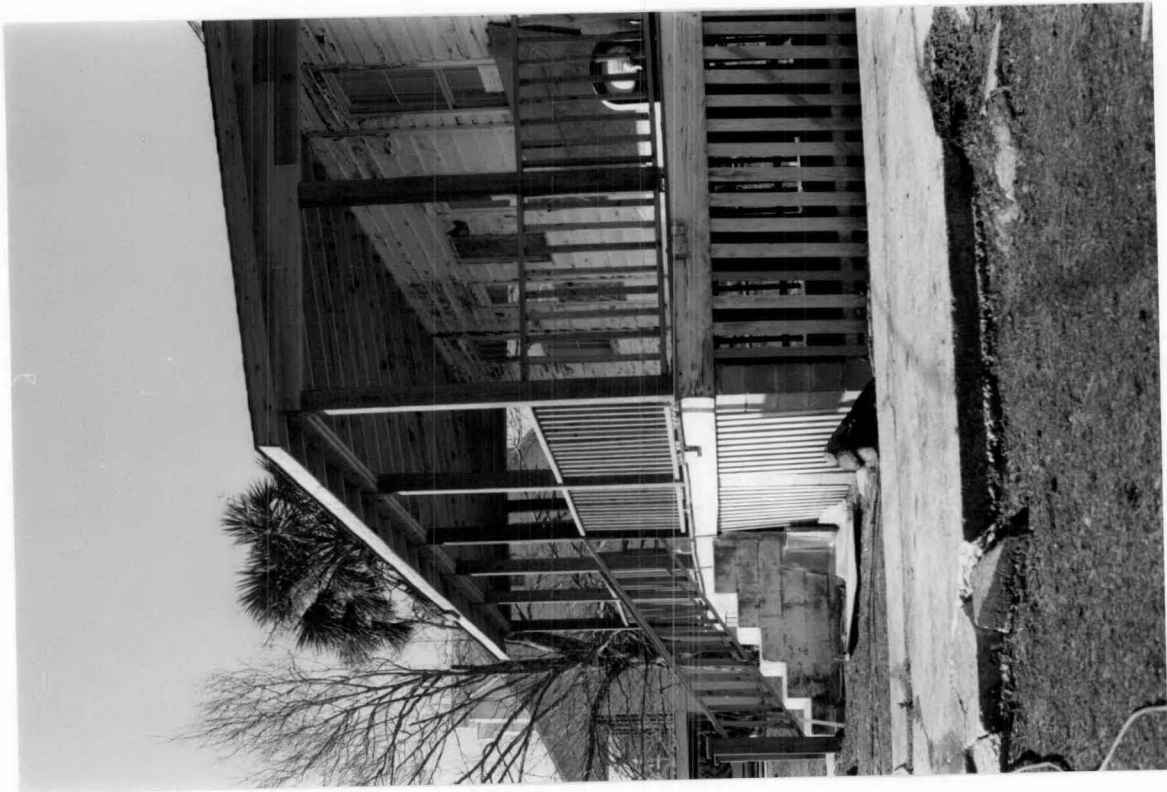
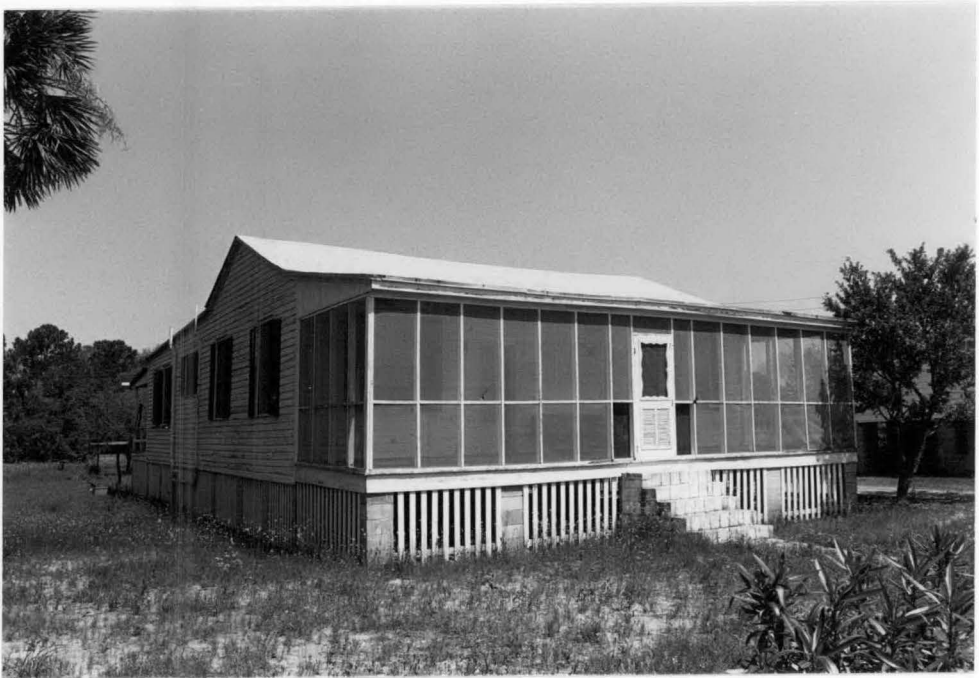
Photo: M4 : 22,23,24

FACADE	RIGHT	LEFT	REAR	
A) Structural Damage	50%	45%	45%	35%	* <u>roof structure, porch, gables - Coded Red</u>
B) Foundation					* <u>NAD</u>
C) Principal Roof					* <u>100% - new comp shingles</u>
D) Porch Roof					* <u>100% - new comp shingles</u>
E) Dormers					* <u>NA</u>
F) Chimneys					* <u>NA</u>
G) Exterior Siding	NAD	40%	25%	NAD	* <u>replaced w'board</u>
H) Porch Trim					* <u>100% replaced</u>
I) Windows	25%	20%	10%	NAD	* <u></u>
J) Detail/Trim Work	40%	30%	40%	50%	* <u>muntins, stair rails, slatted curtain wall,</u>
K) Other					* <u>moulding strips</u>

New roof structure (100%) with new gable vents. New exposed, open-eave notched raftered roof with 1/2-gables. New sawn balustrade.
