852 Middle Street, Sullivan's Island Structural Assessment

August 2, 2021

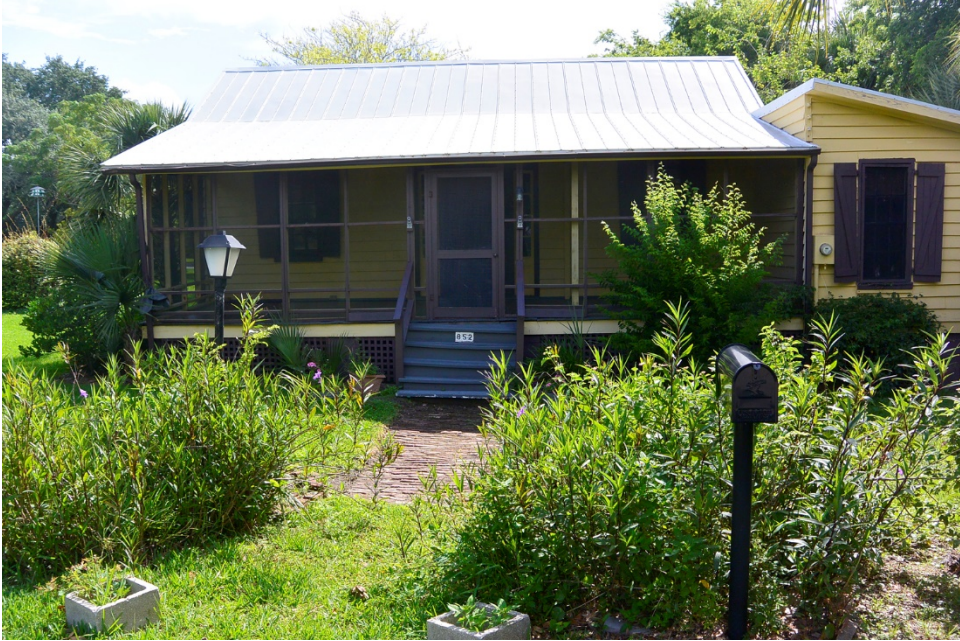
Photo 1

852 Middle Street is a one story wood framed house. Facing the house from the street you are looking at the west elevation of the house. The main body of the house is a simple gable shape with the ridge running north to south. There is a shed roof porch to the street, and a shed roof to the rear that extends over a kitchen, a back porch, and a bedroom. This is most likely the original form of the house. On the south end of the gable, there has been attached an addition with an unusual shaped roof; hip shaped in the rear, or southeast corner, and shed shaped in the front, or southwest corner. My only thought to as why there is a shed roof addition at the front of the house is that if the plate height of the original front porch, which is fairly low, was carried all the way across the front, then turned down the south side of the addition, the rooms in the addition would then have very low ceilings. (see Photo 1)

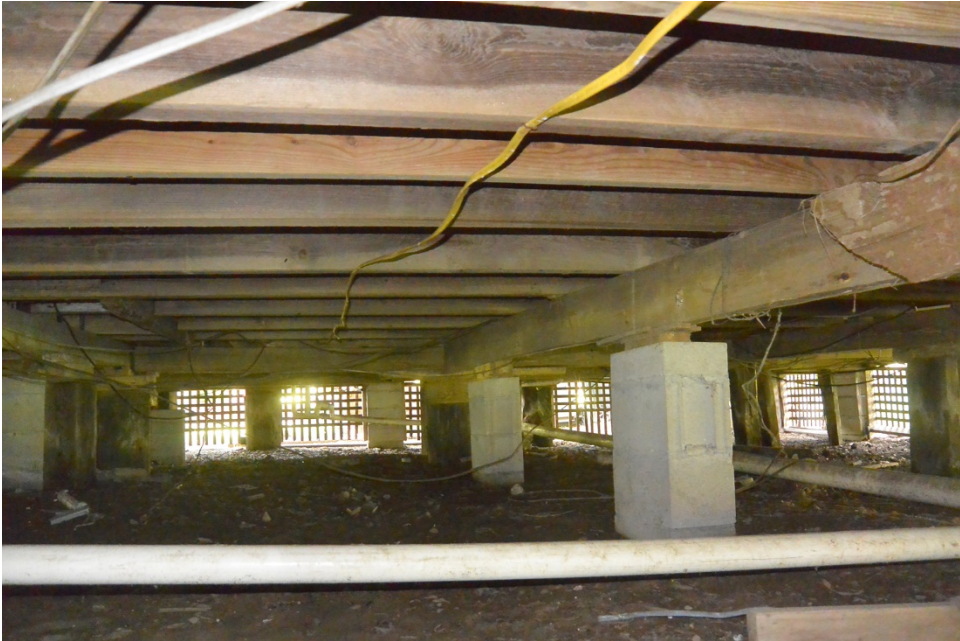
Photo 2

The original and addition's foundation of the house consists of round or rectangular timber piles, traditionally either driven or jetted to some depth. (see Photo 2) The bottom of some of the piles seemed to be at grade in some instances, suggesting they were not driven into the ground at all, but placed like piers just at or slightly below grade. (see Photo 3) It was difficult to determine without digging. Immediately adjacent to many of the piles are concrete block piers, which may or may not be supported by footings. The block piers are also placed where timber piles were most likely located but have since been removed. The piles for the original house are in rows running north to south, with the rows being approximately seven feet apart, with the front porch bay closer to 8 feet. Spanning from pile to pile are wood girders of various sizes. Almost all the girders are shimmed up from the top of the piles or piers various amounts by blocks of wood, with no connection between pile or pier and the girder. The floor joists span east to west over the girders and are in general 3x6's at approximately 27 inches on center. The finish flooring is laid directly on the joists with no subfloor. The front porch framing appears to be not as old as the rest of the

The timber piles are in considerably poor condition. Most are rotten, many are so rotten at the ground level that they seem to have separated from the remaining pile in the ground, if indeed the piles were driven below grade. In some instances the round or rectangular piles appeared to stop at grade or just below similar to a pier. (see Photo 3) It was difficult to determine their extent without digging adjacent to a pile. The concrete block piers have obviously been placed adjacent to extremely deteriorated piles, and some have been located to replace a removed deteriorated pile. The tops of the remaining wood piles and the concrete block piers are not at a consistent elevation (possibly indicating they are not driven piles but the tops of piles bearing at grade and settling), and so nearly every pile or pier has a leveling block of wood placed on top. (see Photo 5) Some of the concrete piers appear to have settled.....perhaps they do not bear on a proper footing.....and no longer provide bearing for the girder. Most of the concrete block piers were constructed with mortar, however some of the piers are dry stacked, have settled, and the blocks have shifted in relation to one another in the stack. (See Photo 4) This lack of a consistent bearing elevation for the floor framing can be seen inside the house in unlevel floors. None of the piles or

piers had a structural connection to the girder. In general, the house has an extremely poor and deteriorated foundation.

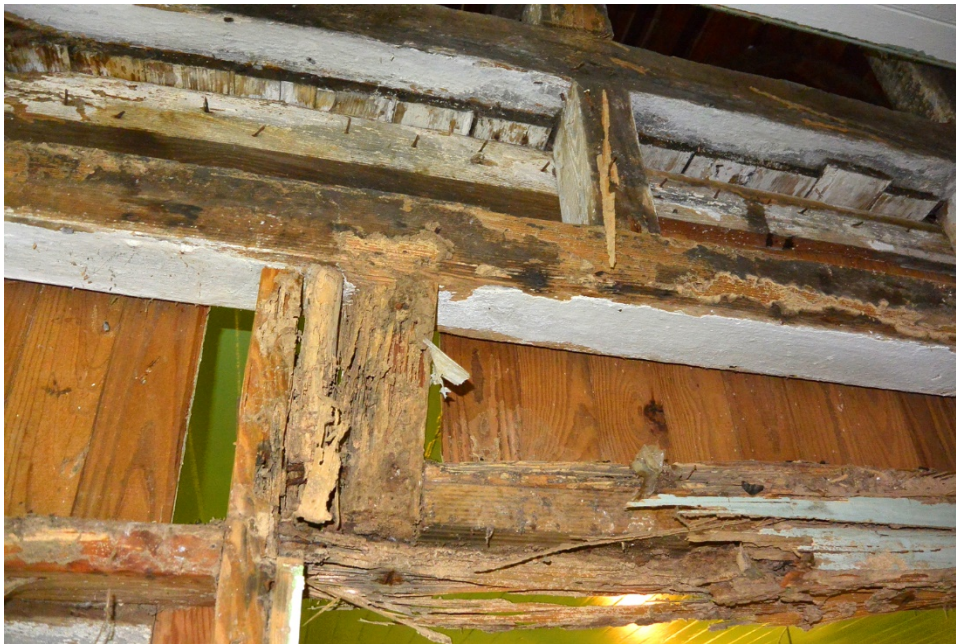
Photo 6

There is a considerable amount of termite damage to the stud framing that is exposed inside the house. (see Photo 6) You can see the deterioration of many of the studs' base from the crawl space. The termite damage extends to the wall top plate which can be seen as deteriorated from below inside the house and deteriorated from above inside the attic.

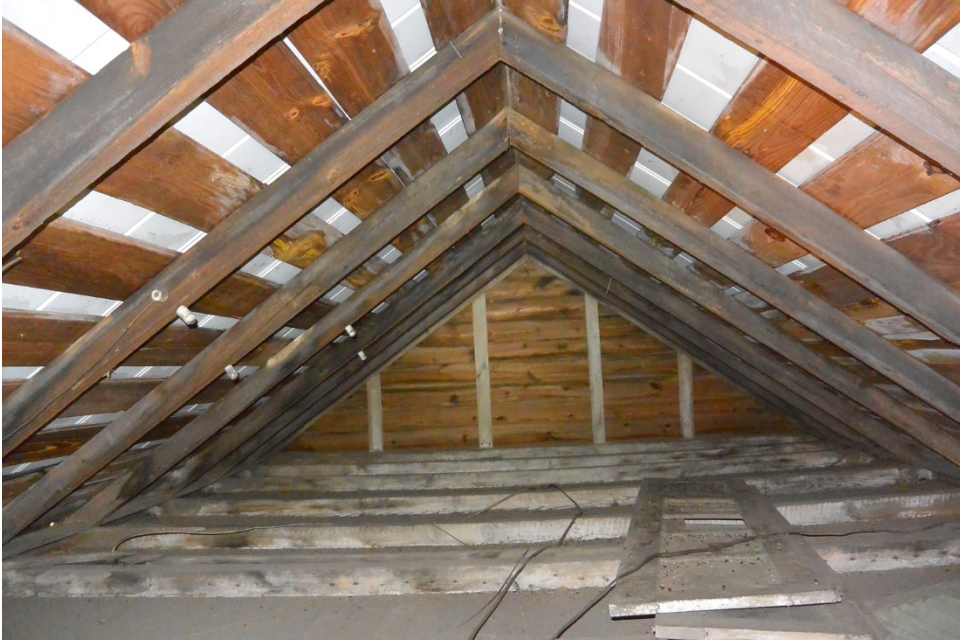
Photo 7

The accessible attic space is directly above the original main gable shape of the house. (see Photo 7) The attic is empty except for the occasional wire. 3x4 attic joists at 32 inches on center span the 14 feet of the gable depth and bear on the bearing walls' top plate. On top of the joist end there is a 1x plate that the rafters bear on. The rafters align with the ceiling joists at 32 inches on center, are 3x4's and span from the 1x plate to the peak of the roof where they abut the corresponding 3x4 coming from the other side of the roof. There is no ridge beam or ridge board. On top of the rafters are spaced ¾ x 8 inch slats, which support a metal roof. No other portion of the attic space or rafter framing was accessible to view.

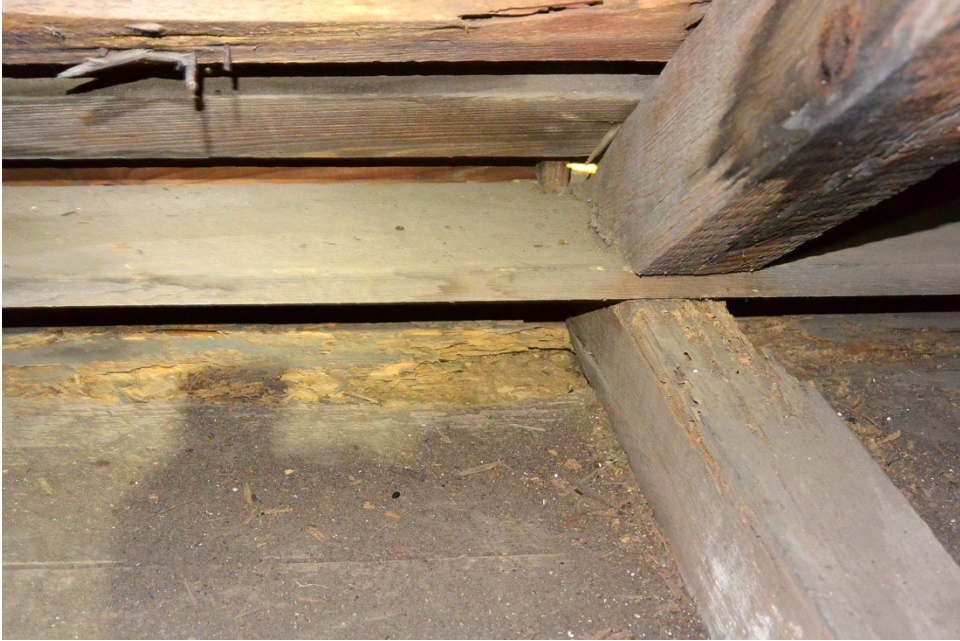
Photo 8

Some of the attic joists are termite damaged where they bear on a deteriorated top of wall plate. (see Photo 8) Some of the roof rafters have been water stained at roof leaks and have been termite damaged where they bear on the 1x plate above the attic joists. Nearly all the roof rafters and ceiling joists seem sound (they may need to be drilled to determine there are no internal termite tracks) except for at their bearings.
