852 Middle Street, Sullivan's Island Structural Assessment

August 2, 2021

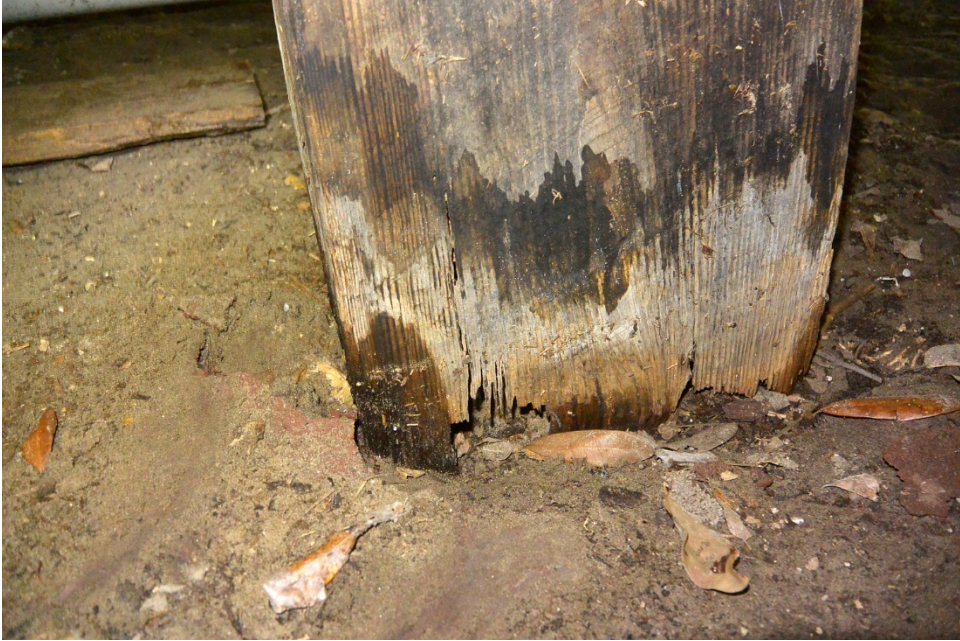
Photo 2

The original and addition's foundation of the house consists of round or rectangular timber piles, traditionally either driven or jetted to some depth. (see Photo 2) The bottom of some of the piles seemed to be at grade in some instances, suggesting they were not driven into the ground at all, but placed like piers just at or slightly below grade. (see Photo 3) It was difficult to determine without digging. Immediately adjacent to many of the piles are concrete block piers, which may or may not be supported by footings. The block piers are also placed where timber piles were most likely located but have since been removed. The piles for the original house are in rows running north to south, with the rows being approximately seven feet apart, with the front porch bay closer to 8 feet. Spanning from pile to pile are wood girders of various sizes. Almost all the girders are shimmed up from the top of the piles or piers various amounts by blocks of wood, with no connection between pile or pier and the girder. The floor joists span east to west over the girders and are in general 3x6's at approximately 27 inches on center. The finish flooring is laid directly on the joists with no subfloor. The front porch framing appears to be not as old as the rest of the
